ANALYSIS AND DOCUMENTATION OF THE  
“MITHOLZ” UNDERGROUND AMMUNITION STORAGE  
ACCIDENTAL EXPLOSION IN SWITZERLAND

Twenty-Seventh DoD Explosives Safety Seminar  
Department of Defense Explosives Safety Board  
Las Vegas, Nevada

August 20 - 22, 1996

**HANSJÖRG RYTZ and KHOSROW BAKHTAR**

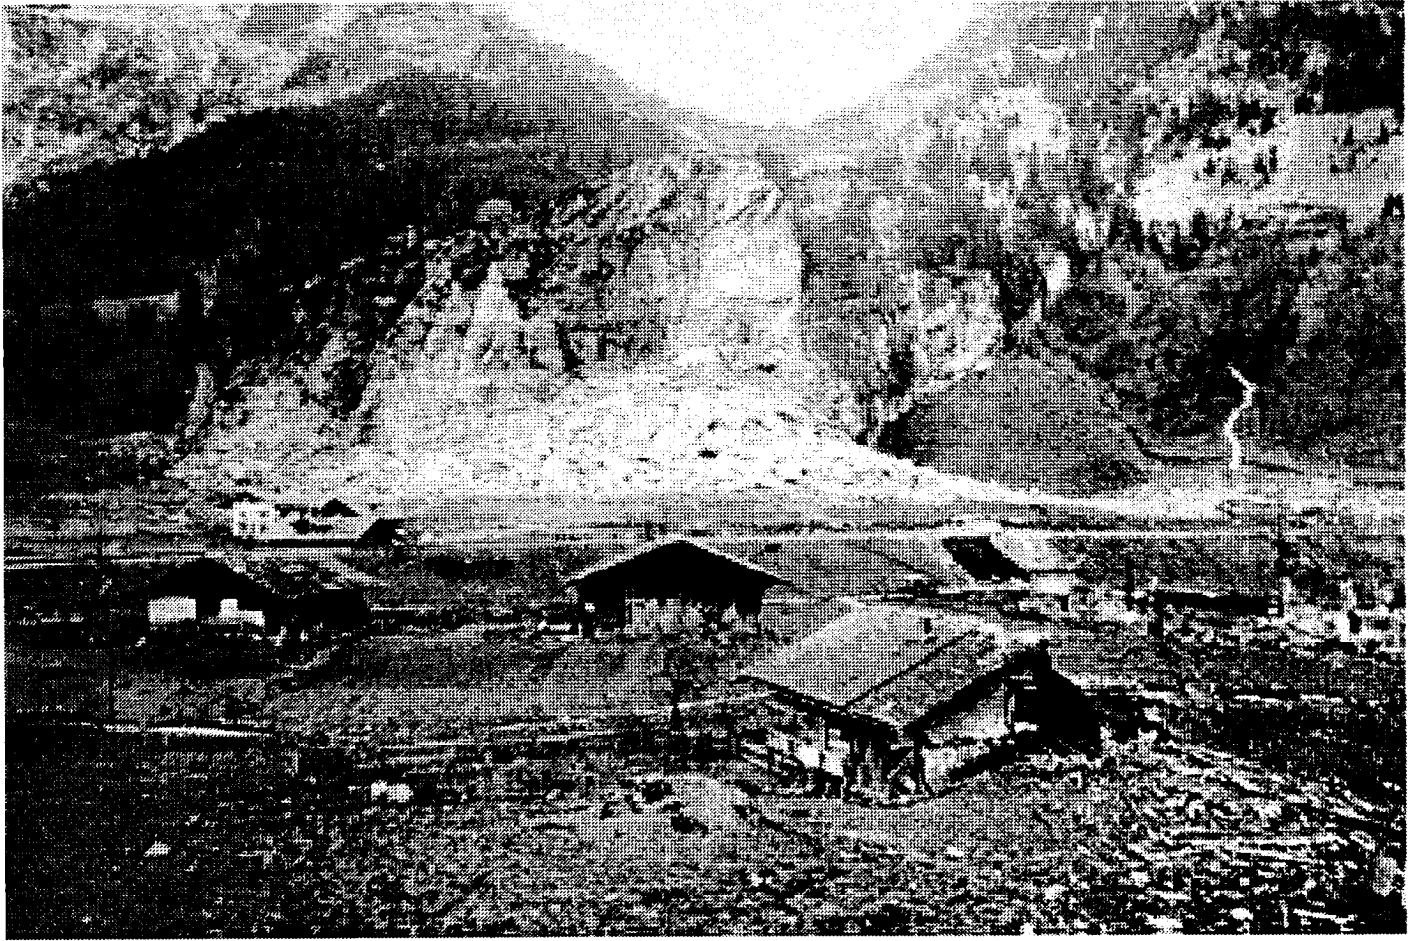
*Figure 7. Showing Location of Buildings at the Accident Site.*

*Ten minutes past midnight the third and most powerful explosion threw out an enormous amount of ammunition, burning explosives and rock debris of various sizes - together with blast flames up to 150 m high. This followed by the collapse of the northern edge of rock wall. Figures 4 to 10 provide details of damage caused by the blast in the area.*
